**Flood Control Project Maintenance  
Levee Inspections**

**Fall 2018 Levee Maintenance Deficiency Summary Report**

**Flood Control Project Maintenance  
Levee Inspections****LMA District Cover Sheet****Fall 2018 Levee Inspection Results****Reclamation District No. 0817 Carlin**

**Reclamation District No. 0817 Carlin**

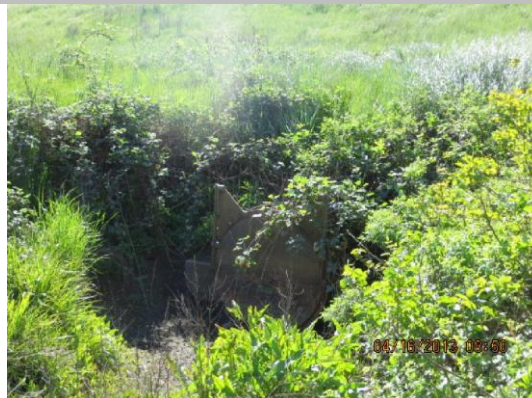
Photo 1 of 3 : UCIP\_FA\_2018\_42685\_19865.jpg

LM Start	0.29	Rating **	M	Issue No.	28
LM End	0.29	Issue Type +	Ma	Location *	
Category	Supplemental			GPS Latitude/Longitude	
				Start	End
Item	DWR UCIP LMA Responsibility			38.987813 °	38.987813 °
				-121.502963 °	-121.502963 °
DWR ID	18985				
Comment Code					
Inspector Comment					
FS_ID:42685 DS_ID:18985 EP_NO: N/A Repair Type: Non-Urgent Crossing Status: Found UCIP Comments: 04/16/2013 Dense vegetation on waterward and landward slopes limit visual inspection of potential leaks along pipe alignment. Recommend having owner clear vegetation along slopes. (P. Amatya - DWR UCIP) FIELD_STRUCT_DESC: 48-inch corrugated metal gravity drainage pipe through the levee, 23.3 feet below the crown. Flap gate on the waterside (WS) end. [Additional Reference(s): DWR Levee Log, 2005. USACE Sacramento O&M Manual 146, November 1962, (HLM 0.28)]. FS Date: 4/16/2013

WS- pipe, flap gate in dense vegetation on berm

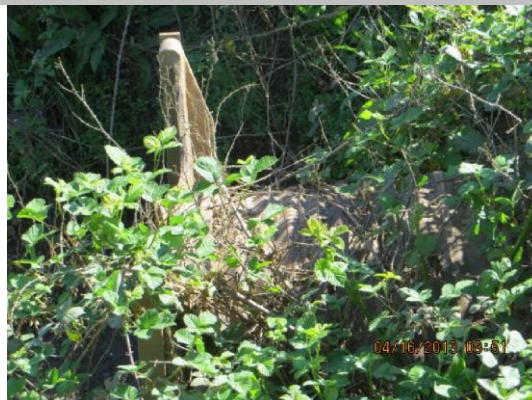
Photo 2 of 3 : UCIP\_FA\_2018\_42685\_19864.jpg

WS- CM pipe and flap gate

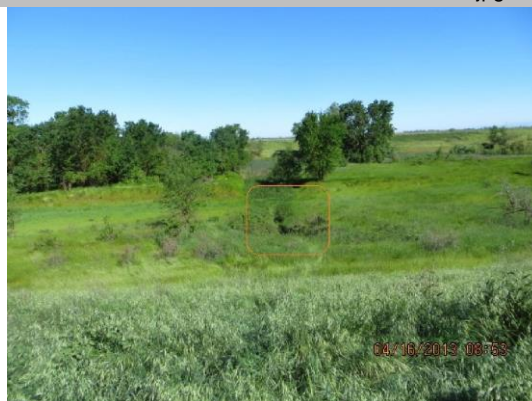
Photo 3 of 3 : UCIP\_FA\_2018\_42685\_19863.jpg

LM Start	0.29	Rating **	M	Issue No.	28 (cont)	
LM End	0.29	Issue Type +	Ma	Location *		
Category	Supplemental			GPS Latitude/Longitude		
				Start		End
Item	DWR UCIP LMA Responsibility			38.987813 °		38.987813 °
				-121.502963 °		-121.502963 °
DWR ID	18985					
Comment Code						
Inspector Comment						
FS_ID:42685 DS_ID:18985 EP_NO: N/A Repair Type: Non-Urgent Crossing Status: Found UCIP Comments: 04/16/2013 Dense vegetation on waterward and landward slopes limit visual inspection of potential leaks along pipe alignment. Recommend having owner clear vegetation along slopes. (P. Amatya - DWR UCIP) FIELD_STRUCT_DESC: 48-inch corrugated metal gravity drainage pipe through the levee, 23.3 feet below the crown. Flap gate on the waterside (WS) end. [Additional Reference(s): DWR Levee Log, 2005. USACE Sacramento O&M Manual 146, November 1962, (HLM 0.28)]. FS Date: 4/16/2013

WS- dense vegetation on WS of the levee

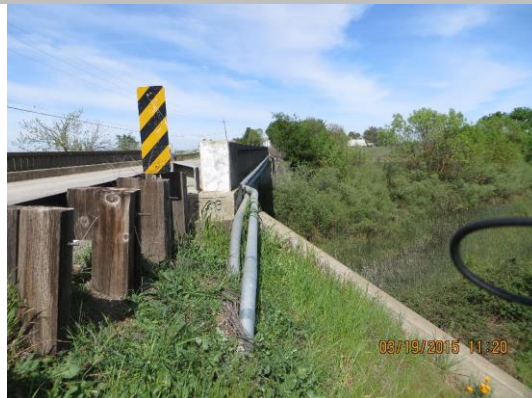
Photo 1 of 2 : UCIP\_FA\_2018\_44084\_73565.jpg

LM Start	1.13	Rating **	M	Issue No.	34
LM End	1.13	Issue Type +	En	Location *	
Category	Supplemental			GPS Latitude/Longitude	
				Start	End
Item	DWR UCIP Field Study			38.995667 °	38.995667 °
				-121.490981 °	-121.490981 °
DWR ID	25088				
Comment Code					
Inspector Comment					
FS_ID:44084 DS_ID:25088 EP_NO: N/A Repair Type: Non-Urgent Crossing Status: Found UCIP Comments: 03/19/2015 No permit identified for this crossing. (P. Amatya - DWR UCIP) FIELD_STRUCT_DESC: *DUPLICATE--DELETE ENTRY* 4-inch steel telephone conduit through the levee, 4 feet below the crown. FS Date: 3/19/2015

Communication conduit visible on upstream side of bridge.

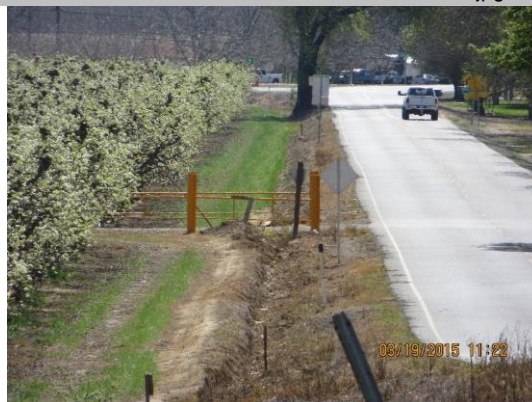
Photo 2 of 2 : UCIP\_FA\_2018\_44084\_73564.jpg

Fiberoptic line markers along roadway to south of bridge.

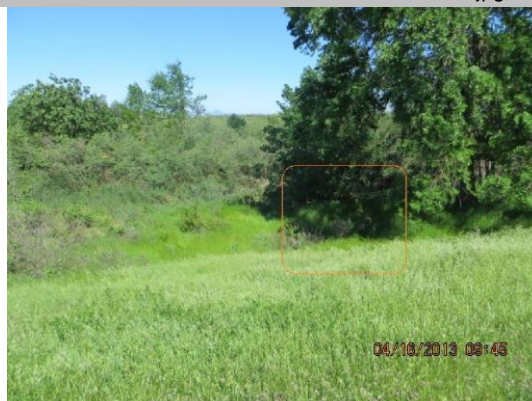
Photo 1 of 3 : UCIP\_FA\_2018\_41153\_19882.jpg

Comment Code					
Inspector Comment					
FS_ID:41153					
DS_ID:18987					
EP_NO: N/A					
Repair Type: Non-Urgent					
Crossing Status: Found					
UCIP Comments: 04/16/2013 Damaged slide gate on WS of the levee. Need to contact owner to determine status of crossing. If crossing is no longer in use owner will need to contact CVFPB to comply with Title 23. Dense vegetation on waterward and landward slopes limit visual inspection of potential leaks along pipe alignment. Recommend having owner clear vegetation along slopes. (P. Amatya - DWR UCIP)					
FIELD_STRUCT_DESC: *ABANDONED* 18-inch corrugated metal gravity drainage pipe through the levee, 14.9 feet below the crown. Slide gate on the waterside (WS) end. [Additional Reference(s): DWR Levee Log, 2005. USACE Sacramento O&M Manual 146, November 1962, (HLM 1.34)].					
FS Date: 4/16/2013

WS- overview of WS area

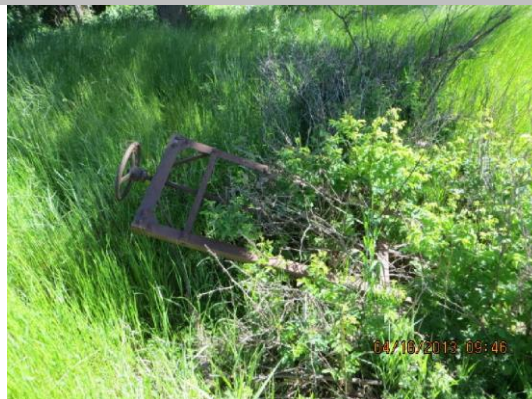
Photo 2 of 3 : UCIP\_FA\_2018\_41153\_19881.jpg

WS- closer look at damaged slide gate on WS

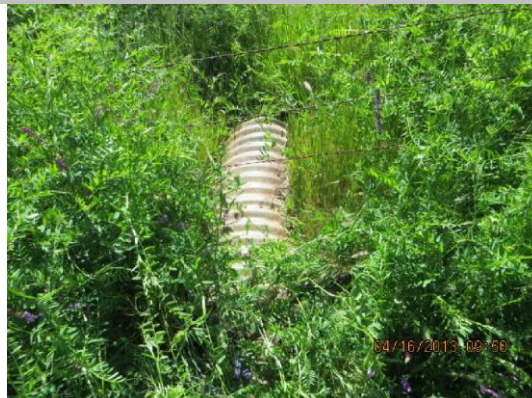
Photo 3 of 3 : UCIP\_FA\_2018\_41153\_19884.jpg

Comment Code						
Inspector Comment						
FS_ID:41153 DS_ID:18987 EP_NO: N/A Repair Type: Non-Urgent Crossing Status: Found UCIP Comments: 04/16/2013 Damaged slide gate on WS of the levee. Need to contact owner to determine status of crossing. If crossing is no longer in use owner will need to contact CVFPB to comply with Title 23. Dense vegetation on waterward and landward slopes limit visual inspection of potential leaks along pipe alignment. Recommend having owner clear vegetation along slopes. (P. Amatya - DWR UCIP) FIELD_STRUCT_DESC: *ABANDONED* 18-inch corrugated metal gravity drainage pipe through the levee, 14.9 feet below the crown. Slide gate on the waterside (WS) end. [Additional Reference(s): DWR Levee Log, 2005. USACE Sacramento O&M Manual 146, November 1962, (HLM 1.34)]. FS Date: 4/16/2013

LS- CMP on toe of the levee.

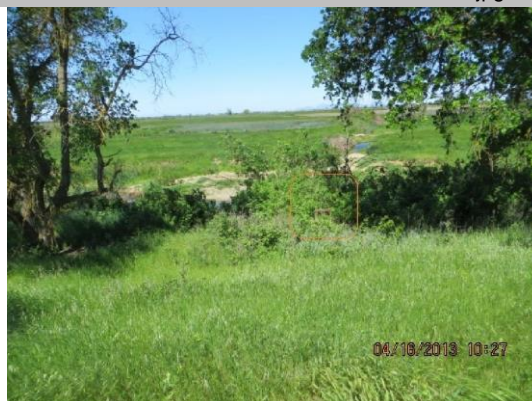
Photo 1 of 3 : UCIP\_FA\_2018\_41157\_19892.jpg

Comment Code					
Inspector Comment					
FS_ID:41157 DS_ID:18988 EP_NO: N/A Repair Type: Non-Urgent Crossing Status: Found UCIP Comments: 04/16/2013 A buried slide gate on WS of the levee. Need to contact owner to determine status of crossing. If crossing is no longer in use owner will need to contact CVFPB to comply with Title 23. Dense vegetation on waterward and landward slopes limit visual inspection of potential leaks along pipe alignment. Recommend having owner clear vegetation along slopes. (P. Amatya - DWR UCIP) FIELD_STRUCT_DESC: *ABANDONED* 18-inch corrugated metal gravity drainage pipe through the levee, 13.8 feet below the crown. Slide gate on the waterside (WS) end. [Additional Reference(s): DWR Levee Log, 2005. USACE Sacramento O&M Manual 146, November 1962, (HLM 1.62)]. FS Date: 4/16/2013

WS- overview of WS berm

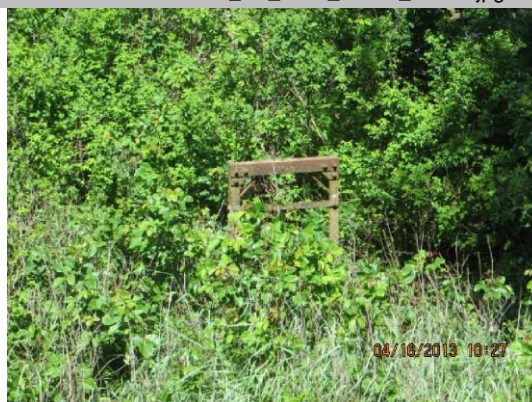
Photo 2 of 3 : UCIP\_FA\_2018\_41157\_19891.jpg

WS- slide gate

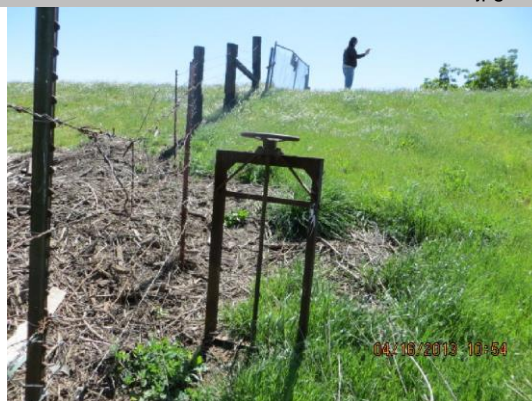
Photo 1 of 1 : UCIP\_FA\_2018\_41156\_19895.jpg

Comment Code						
Inspector Comment						
FS_ID:41156 DS_ID:18989 EP_NO: N/A Repair Type: Non-Urgent Crossing Status: Indicator Found UCIP Comments: 04/16/2013 A buried slide gate found on WS. Need to contact owner to determine status of crossing. If crossing is no longer in use owner will need to contact CVFPB to comply with Title 23. Dense vegetation on waterward and landward slopes limit visual inspection of potential leaks along pipe alignment. Recommend having owner clear vegetation along slopes. (P. Amatya - DWR UCIP) FIELD_STRUCT_DESC: *ABANDONED* 18-inch corrugated metal gravity drainage pipe through levee, 11.7 feet below the crown. Slide gate on the waterside (WS) end. (Removal of 18-inch pipe and appurtenances authorized under Permit No. 16193, 1994 - Reclamation District No. 817. Slide gate still remains on the WS toe). [Additional Reference(s): DWR Levee Log, 2005. USACE Sacramento O&M Manual 146, November 1962, (HLM 2.29)]. FS Date: 4/16/2013

WS- slide gate on levee toe.

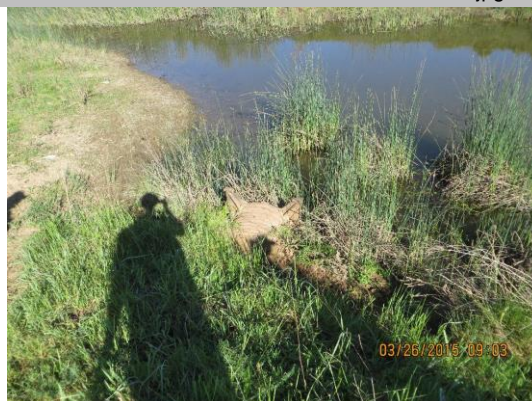
Photo 1 of 3 : UCIP\_FA\_2018\_43946\_73422.jpg

Pipe and flapgate visible on WS toe.

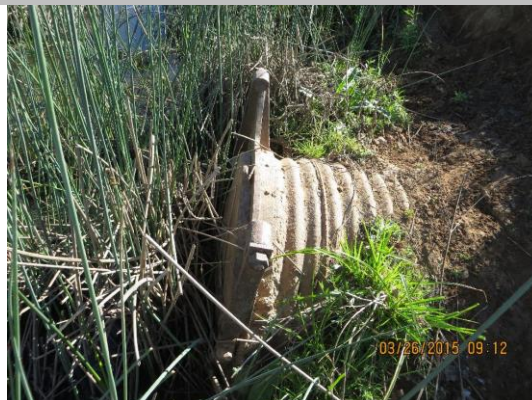
Photo 2 of 3 : UCIP\_FA\_2018\_43946\_73421.jpg

Pipe and flapgate visible on WS toe.

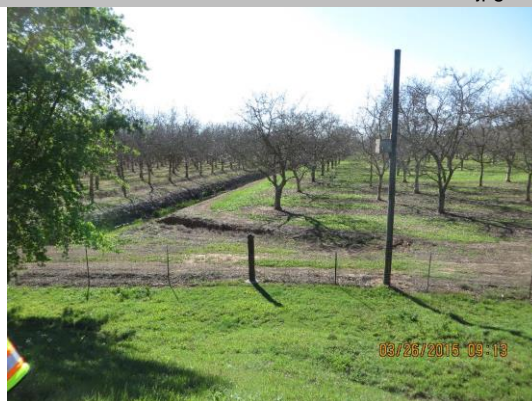
Photo 3 of 3 : UCIP\_FA\_2018\_43946\_73420.jpg

LS of pipe buried but alignment would place LS outlet just left of telephone pole on LS toe.

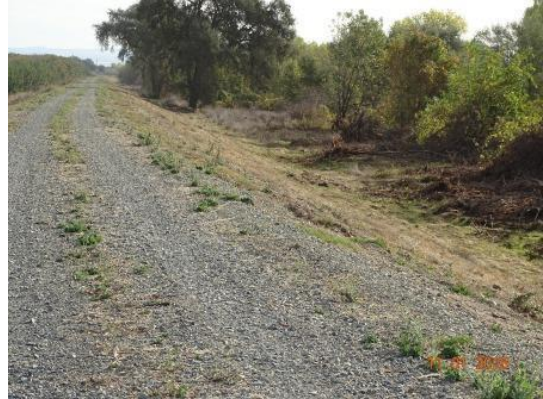
Photo 1 of 1 : FA\_2018\_RD0817\_13\_10\_20181107\_00025.jpg

View looking upstream waterside of the well maintained annual vegetation, Fall 2018.

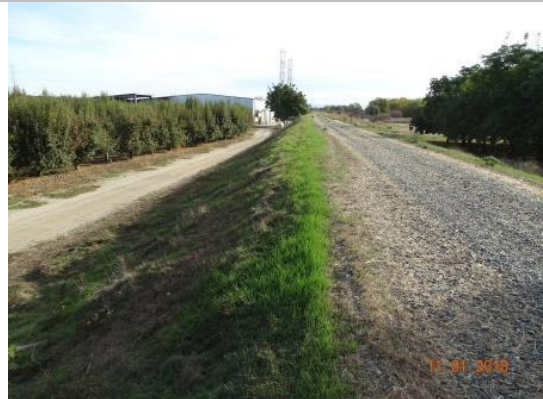
Photo 1 of 1 : FA\_2018\_RD0817\_13\_9\_20181107\_00026.jpg

LM Start	0.00	Rating **	A	Issue No.	9
LM End	3.82	Issue Type +	Ma	Location *	LS
Category	Earthen Levee			GPS Latitude/Longitude	
				Start	End
Item	Vegetation			38.984668 °	38.993136 °
				-121.506106 °	-121.437905 °
DWR ID	DWR_RD0817_02_f_2018_9				
Comment Code					
V1 : Control annual grass and weeds on the levee slopes and easements.					
Inspector Comment					
The annual vegetation is well maintained, Fall 2018.

View looking upstream landside of the well maintained annual vegetation, Fall 2018.

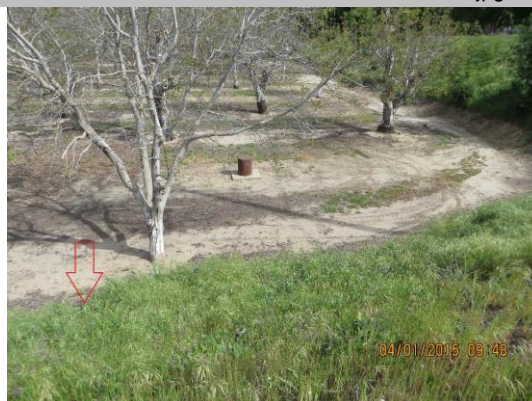
Photo 1 of 3 : UCIP\_FA\_2018\_44064\_73542.jpg

Concrete standpipe visible on lower slope of LS toe.

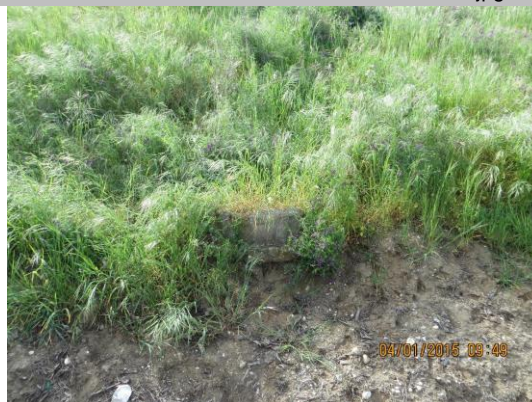
Photo 2 of 3 : UCIP\_FA\_2018\_44064\_73541.jpg

Concrete standpipe visible on lower slope of LS toe.

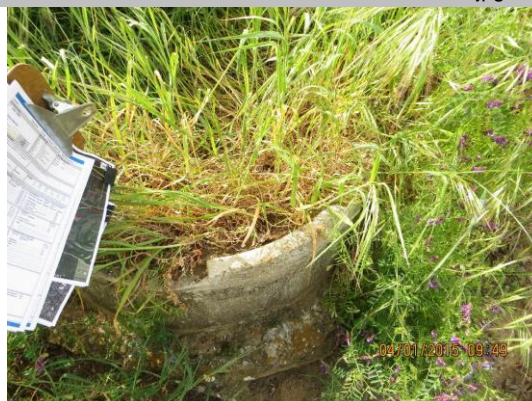
Photo 3 of 3 : UCIP\_FA\_2018\_44064\_73540.jpg

Concrete standpipe visible on lower slope of LS toe.

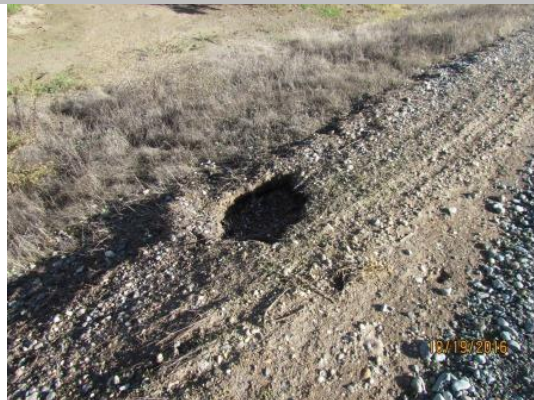
Photo 1 of 1 : FA\_2018\_RD0817\_13\_15\_20180918\_00011.jpg

View of a sink hole were old stump was. This needs to be backfilled and compacted.

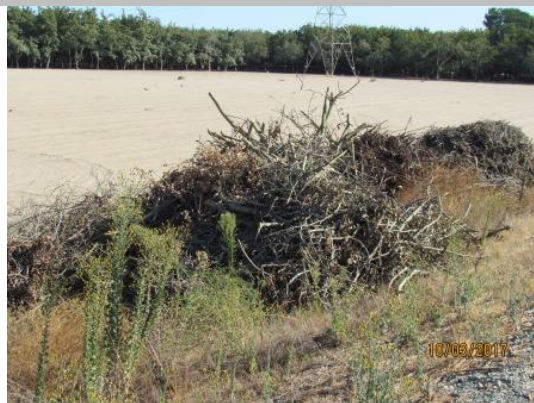
Photo 1 of 1 : FA\_2018\_RD0817\_13\_11\_20180918\_00003.jpg

LM Start	1.54	Rating **	M	Issue No.	11
LM End	1.54	Issue Type +	En	Location *	LS
Category	Earthen Levee			GPS Latitude/Longitude	
				Start	End
Item	Encroachments			38.986877 °	38.986877 °
				-121.478175 °	-121.478175 °
DWR ID	DWR_RD0817_02_s_2017_11				
Comment Code					
PR : Prunings					
Inspector Comment					
Have prunings removed from toe area,

View of prunings on the landside levee toe.

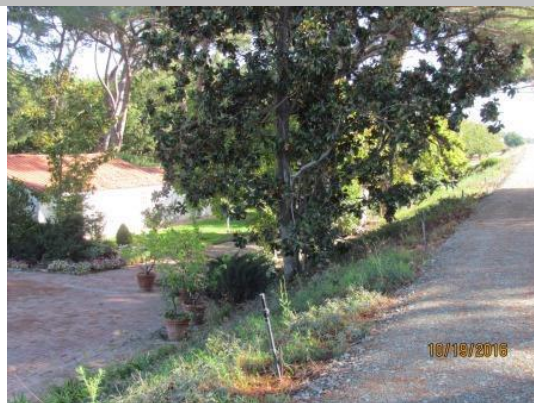
Photo 1 of 1 : FA\_2018\_RD0817\_13\_2\_20180918\_00001.jpg

LM Start	1.76	Rating **	M	Issue No.	2
LM End	1.76	Issue Type +	En	Location *	LS
Category	Earthen Levee			GPS Latitude/Longitude	
				Start	End
Item	Vegetation			38.987851 °	38.987851 °
				-121.474383 °	-121.474383 °
DWR ID	DWR_RD0817_02_f_2013_2				
Comment Code					
V6 : Landscaping					
Inspector Comment					
The homeowners landscape vegetation is creeping up the landside levee slope.

View of the homeowners landscape vegetation creeping up the landside levee slope, looking upstream.

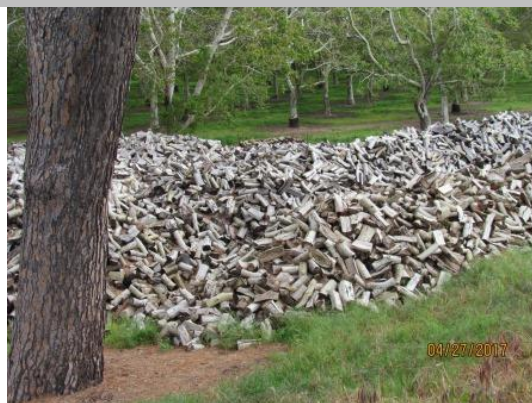
Photo 1 of 1 : FA\_2018\_RD0817\_13\_12\_20180918\_00004.jpg

View of a large pile of firewood that is encroaching on the landside levee toe, Spring 2017 and still exist during Fall 2018 inspection.

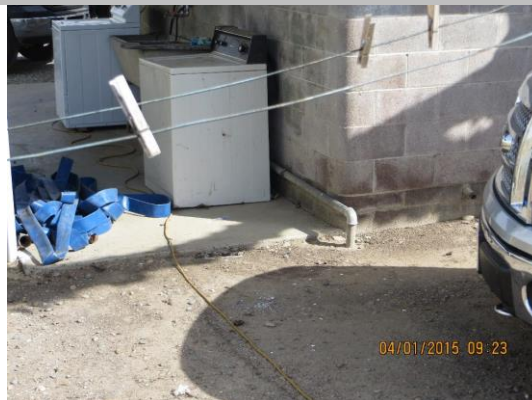
Photo 2 of 3 : UCIP\_FA\_2018\_46182\_74560.jpg

Possible source on LS at building corner.

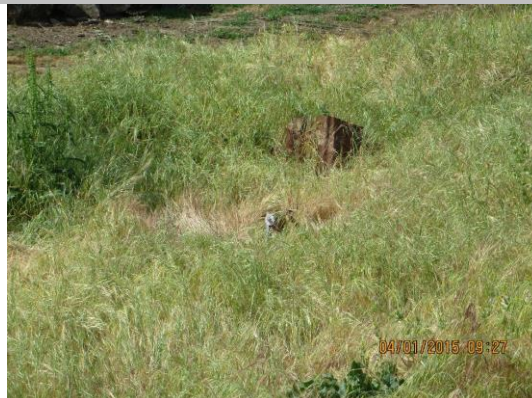
Photo 3 of 3 : UCIP\_FA\_2018\_46182\_74561.jpg

Pipe and hose bib visible in tall grass at WS toe.

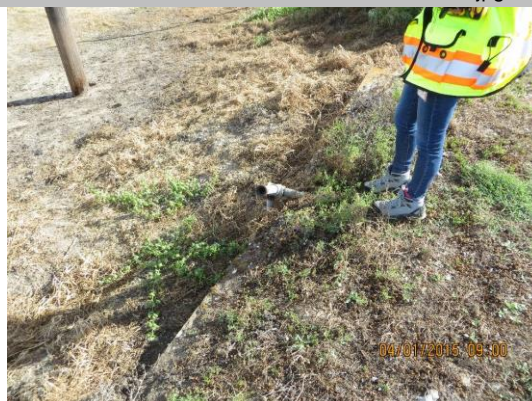
Photo 1 of 3 : UCIP\_FA\_2018\_44105\_73586.jpg

Pipe visible on LS shoulder.

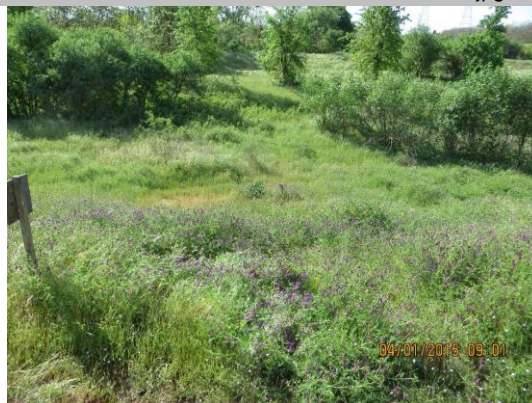
Photo 2 of 3 : UCIP\_FA\_2018\_44105\_73585.jpg

WS slope. pipe not visible.

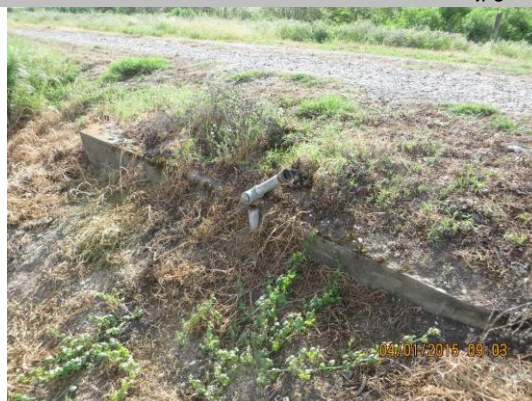
Photo 3 of 3 : UCIP\_FA\_2018\_44105\_73584.jpg

Pipe and concrete headwall visible on LS shoulder.

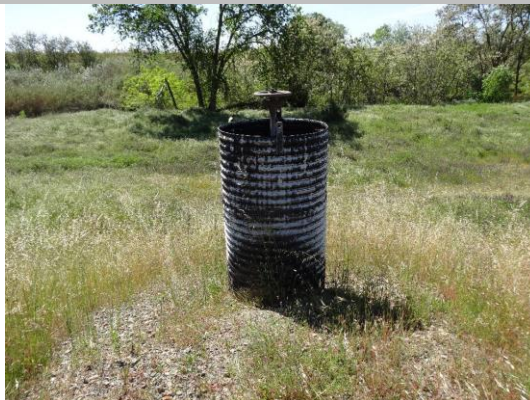
Photo 1 of 3 : UCIP\_FA\_2018\_41160\_19922.jpg

WS- CMP riser on levee slope.

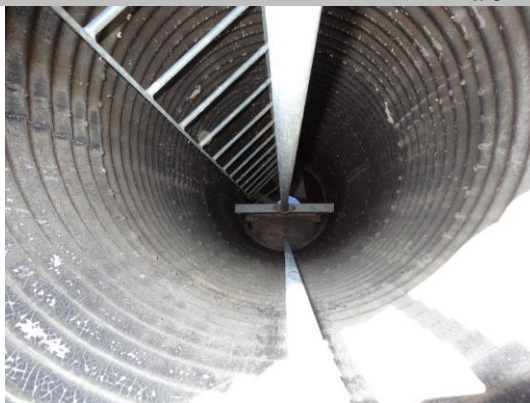
Photo 2 of 3 : UCIP\_FA\_2018\_41160\_19921.jpg

WS- inside CMP riser with air vent and slide gate.

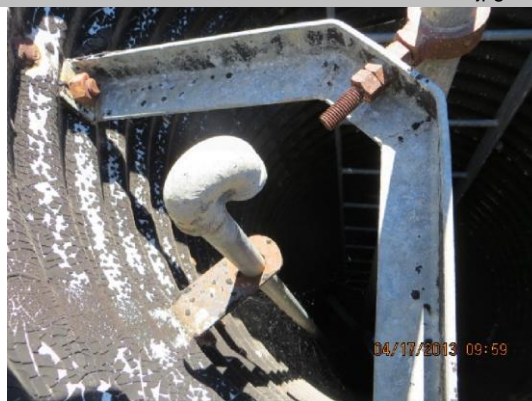
Photo 3 of 3 : UCIP\_FA\_2018\_41160\_19920.jpg

WS- CMP riser with air vent and slide gate.

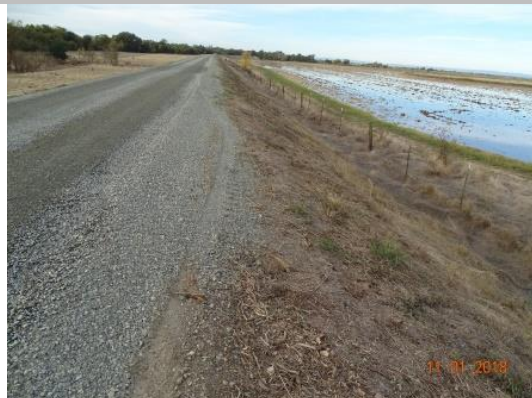
Photo 1 of 1 : FA\_2018\_RD0817\_14\_12\_20181107\_00031.jpg

View looking downstream landside of the annual vegetation that is well maintained, Fall 2018.

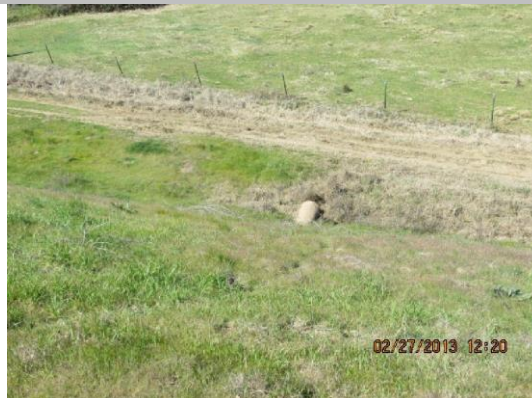
Photo 1 of 3 : UCIP\_FA\_2018\_50231\_54271.jpg

Pipe at LS toe

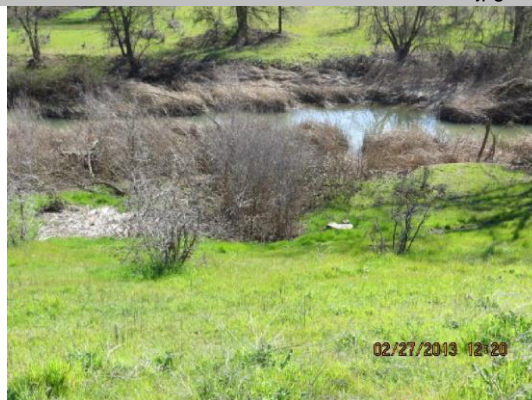
Photo 2 of 3 : UCIP\_FA\_2018\_50231\_54270.jpg

Outlet in brush at WS toe.

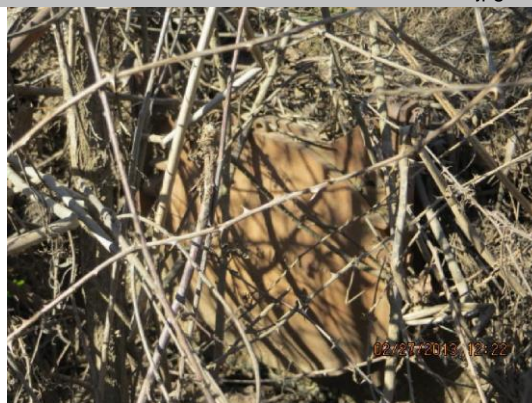
Photo 3 of 3 : UCIP\_FA\_2018\_50231\_54269.jpg

Flap gate blocked by vegetation on WS toe.

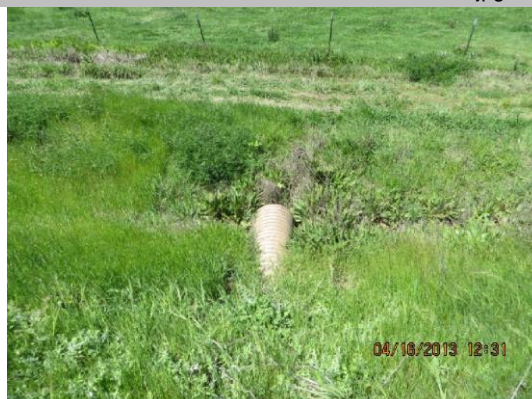
Photo 1 of 3 : UCIP\_FA\_2018\_42686\_19927.jpg

LS- overview of CM drainage pipe on toe of the levee.

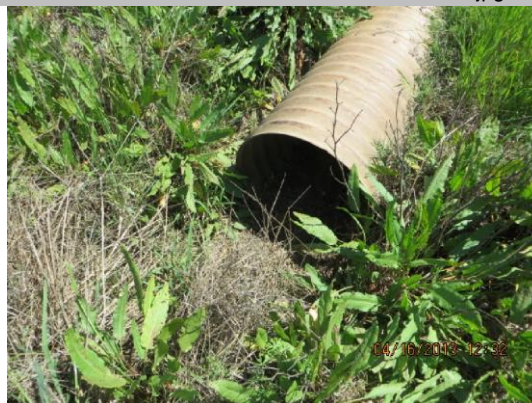
Photo 2 of 3 : UCIP\_FA\_2018\_42686\_19926.jpg

LS- CM drainage pipe on toe of the levee.

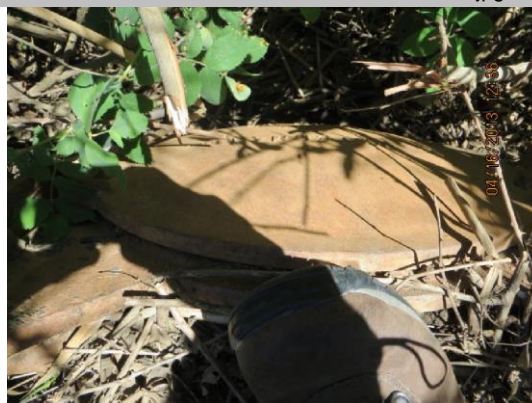
Photo 3 of 3 : UCIP\_FA\_2018\_42686\_19928.jpg

WS- flap gate on CMP end on levee toe.

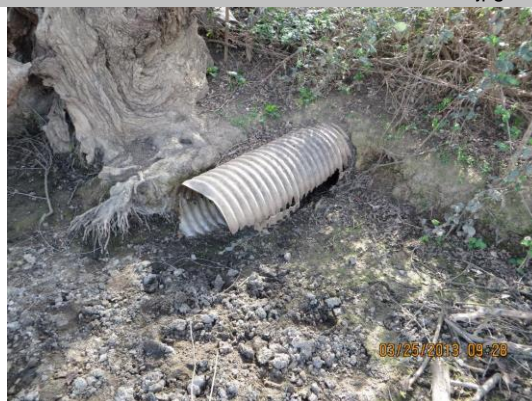
Photo 1 of 3 : UCIP\_FA\_2018\_53420\_53849.jpg

Pipe on LS toe corroded through.

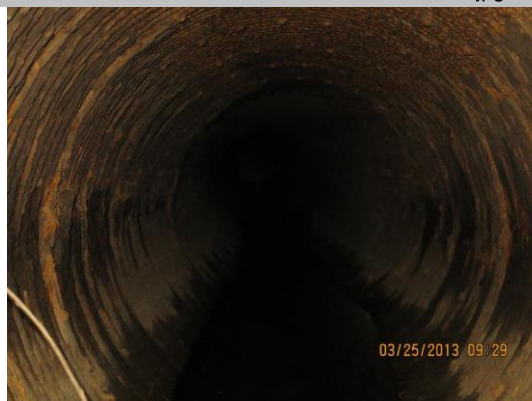
Photo 2 of 3 : UCIP\_FA\_2018\_53420\_53848.jpg

Pipe Heavily corroded throughout

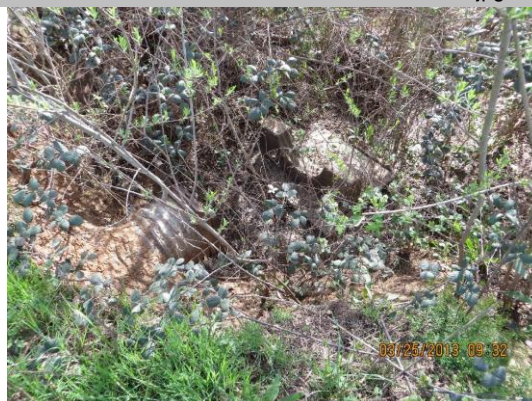
Photo 3 of 3 : UCIP\_FA\_2018\_53420\_53847.jpg

Pipe no longer mounted to headwall at WS toe.

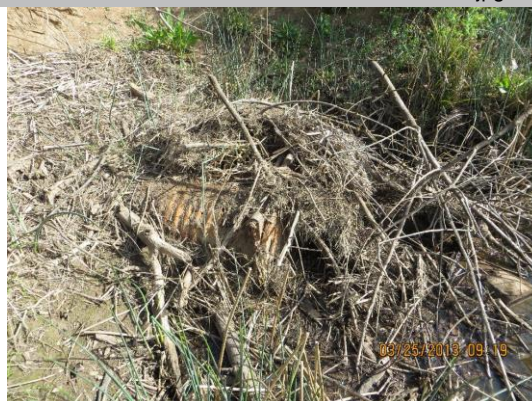
Photo 1 of 3 : UCIP\_FA\_2018\_53421\_53854.jpg

Pipe and flapgate at WS toe blocked by debris.

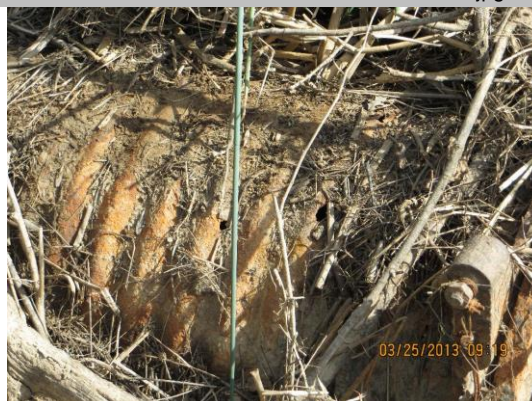
Photo 2 of 3 : UCIP\_FA\_2018\_53421\_53853.jpg

Holes in pipe at broken flapgate on WS toe.

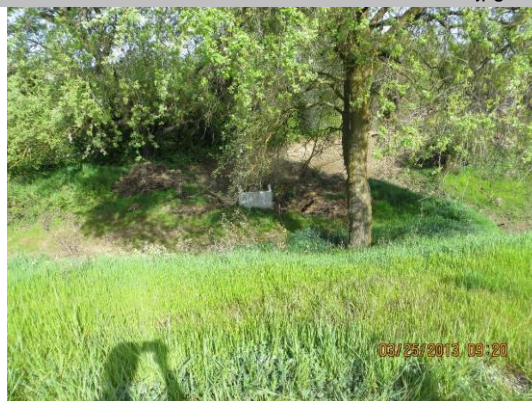
Photo 3 of 3 : UCIP\_FA\_2018\_53421\_53852.jpg

Improvised concrete inlet on LS toe.

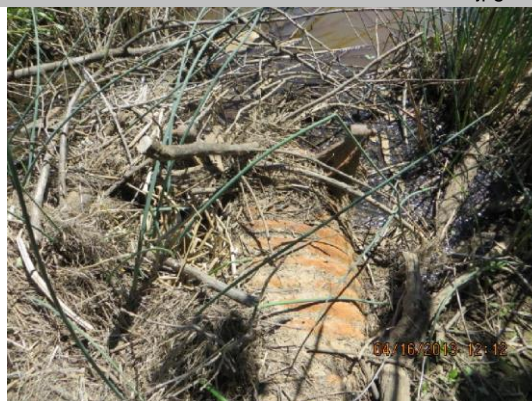
Photo 1 of 3 : UCIP\_FA\_2018\_41163\_19942.jpg

WS- CM pipe, flap gate and debris.

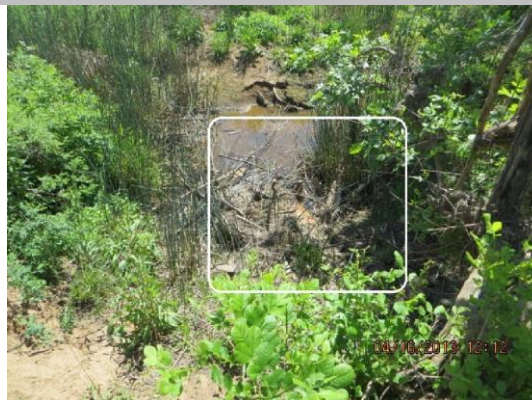
Photo 2 of 3 : UCIP\_FA\_2018\_41163\_19941.jpg

WS- overview of CM pipe, flap gate and debris.

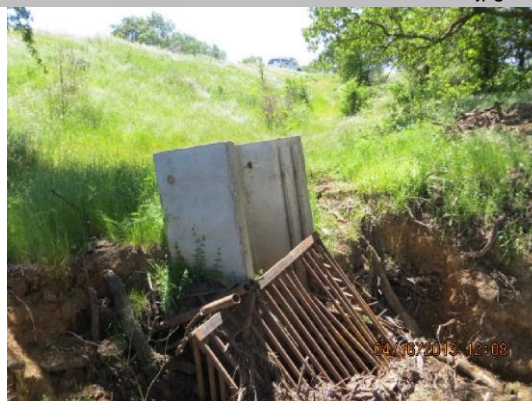
Photo 3 of 3 : UCIP\_FA\_2018\_41163\_19940.jpg

LS- half box concrete outlet structure with trash rack.

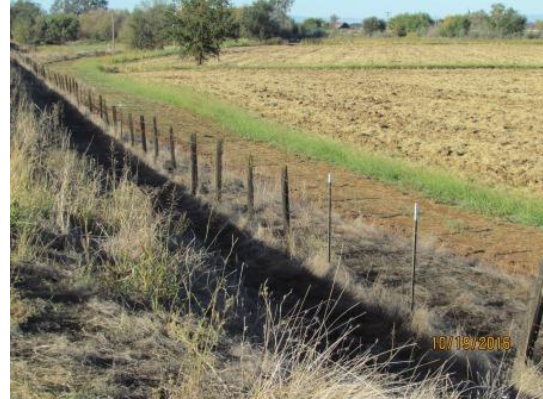
Photo 1 of 1 : FA\_2018\_RD0817\_14\_15\_20180918\_00005.jpg

View of fence at landside toe looking downstream.

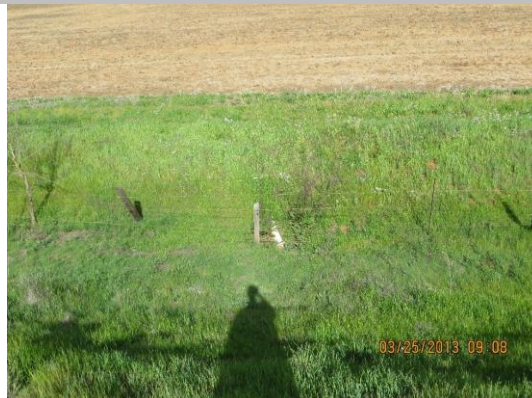
Photo 1 of 3 : UCIP\_FA\_2018\_53422\_53857.jpg

Pipe on LS toe with 8-inch PVC pipe sticking out.

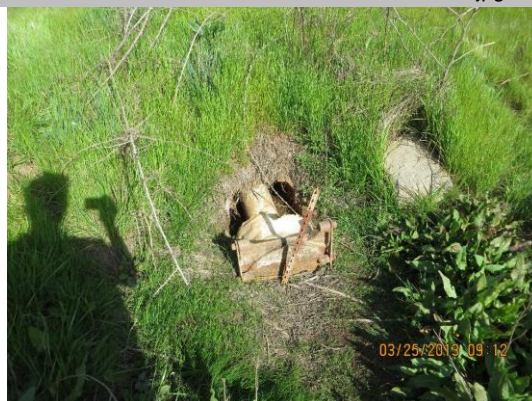
Photo 2 of 3 : UCIP\_FA\_2018\_53422\_53856.jpg

Pipe cut behind flap gate on WS toe with 8-inch PVC.

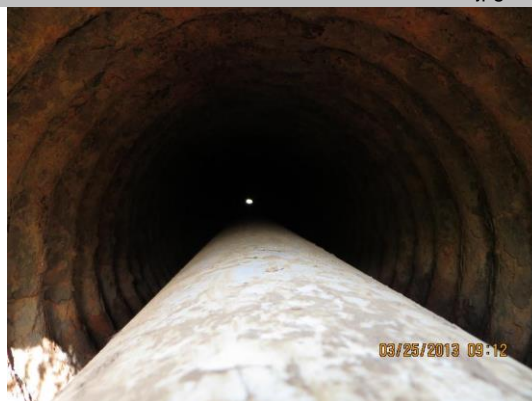
Photo 3 of 3 : UCIP\_FA\_2018\_53422\_53855.jpg

Pipe heavily corroded throughout.

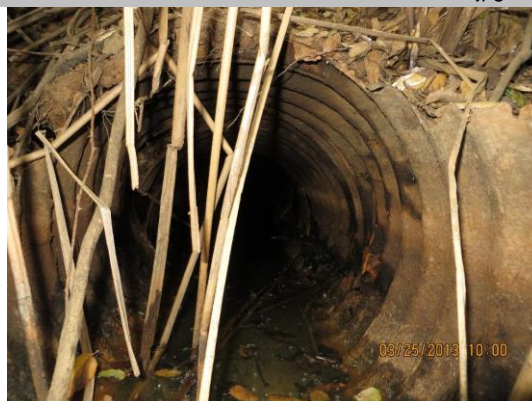
Photo 1 of 3 : UCIP\_FA\_2018\_53423\_53859.jpg

Pipe at inlet on LS toe.

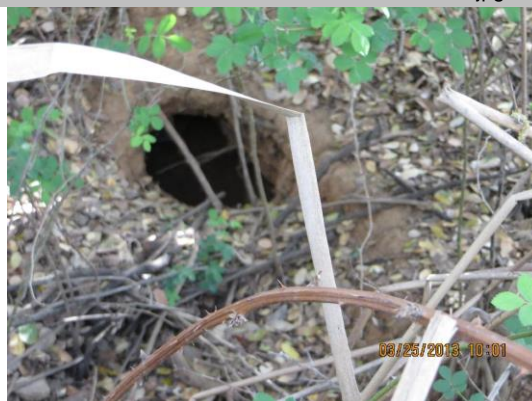
Photo 2 of 3 : UCIP\_FA\_2018\_53423\_53858.jpg

Sinkhole or animal burrow over pipe on LS toe.

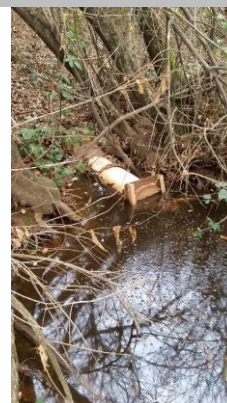
Photo 3 of 3 : UCIP\_FA\_2018\_53423\_74804.jpg

WS drainage outlet with flap gate. Steel pipe is sleeved within heavily rusted CM pipe near daylight to embankment
